# AUTUMN 2026 SAFETY BULLETIN

# UK CASE STUDIES: WHEN ELECTRICAL FAULTS TURNED INTO TRAGEDY

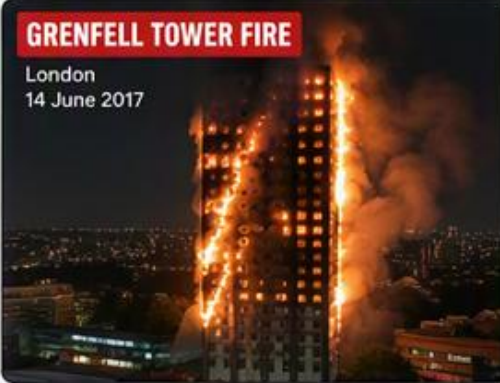
## GRENELL TOWER FIRE

The Grenfell Tower fire claimed 72 lives and changed building safety standards forever.

The investigation found that a fault in a fridge-freezer in Flat 16 started the fire. The appliance was older, and the fault went undetected. This small electrical fault led to an unimaginable tragedy.

Regular inspection of electrical appliances – especially in high-rise buildings – is critical.

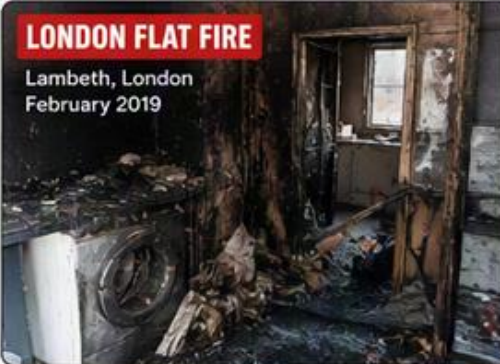
## LONDON FLAT FIRE

A fire broke out in a residential flat, causing extensive damage and displacing the occupants.

The fire was caused by a fault in a tumble dryer due to an accumulation of lint and overheating. The appliance had not been cleaned or maintained properly.

Poor maintenance and lack of cleaning can turn everyday appliances into serious fire risks.

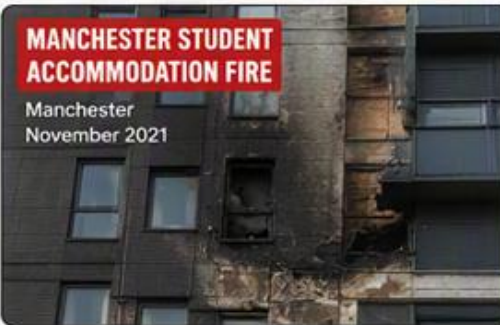
## MANCHESTER STUDENT ACCOMMODATION FIRE

A late-night fire broke out in student accommodation, leading to a large-scale evacuation.

The fire was caused by an overloaded extension lead supplying multiple high-power devices, which overheated and ignited.

Overloading sockets and extension leads is a common but dangerous habit.
